# Appendix C-6: Historical Electrical Conductivity Data

## **APPENDIX C8**

### **DISTANCE-ELEVATION PLOTS**

### **SENTRY WELLS AND TRIGGER VALUES**

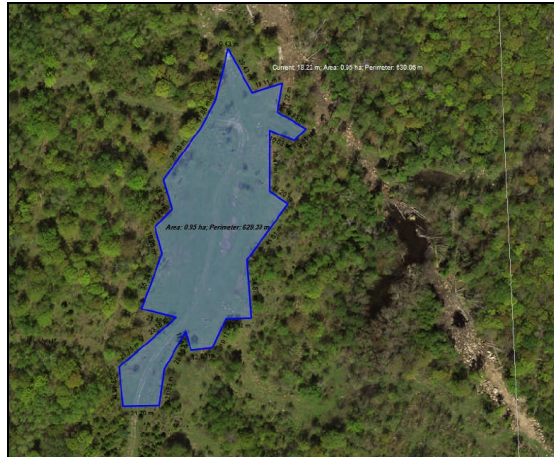
### Sub-compartment 7A

- Area = 0.95 ha or 2.35 ac
- Full or 100% planting stocking density required
- Average tree planting density at 2.5m between rows and 1.7m spacing between trees
- Density target =  $0.95 \times (10000/4.25) =$  approximately 2235
- Planting requirement of 2200 trees, with a minimum height of 25cm at time of planting, composition being :
  - Native Conifers seedlings = 2000
    - White Pine = 1500
    - White Cedar = 250
    - White Spruce = 250
  - Native Hardwood seedlings = 200
    - A mix of various species which could be: Red Oak, White Birch, Black Cherry, Sugar Maple, Aspen/Poplar (non-hybrid)

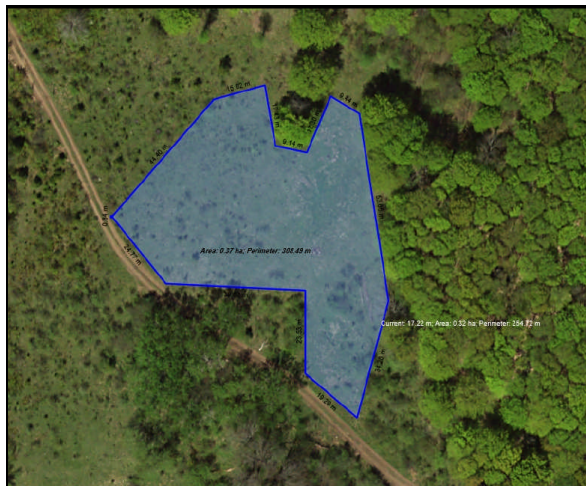
### Sub-Compartment 7B

- Area = 0.37 ha or 0.9 ac
- Scattered trees/tall shrubs existing throughout compartment, thus target density level of 60% planting of total area
- Average tree planting density at 2.5m between rows and 1.7m spacing between trees
- Density target =  $(0.37 \times (10000/4.25)) \times 0.6 = 522$

- Approximately 500 trees, with a minimum height of 25cm at time of planting, composition being :
  - o Conifers = 400
    - White Pine = 200
    - White Cedar = 100
    - White Spruce = 100
  - o Hardwood = 100
    - A mix of various species which could be: Red Oak, White Birch, Black Cherry, Sugar Maple, Aspen/Poplar (non-hybrid)

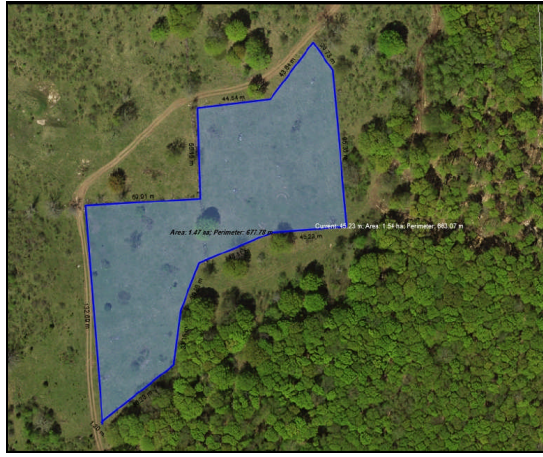
#### Sub-Compartment 7C

- Area = 1.47 ha or 3.63ac
- A few scattered mature trees and tall shrubs through compartment, thus target density level of 90% planting of total area.
- Average tree planting density at 2.5m between rows and 1.7m spacing between trees
- Planting density target =  $(1.47 \times (10000/4.25)) \times 0.9 = 3113$
- Planting requirement of 3100 trees, with a minimum height of 25cm at time of planting, composition being:
  - o Conifers = 2800
    - White Pine = 2000
    - White Cedar = 300
    - White Spruce = 500
  - o Hardwood = 300
    - A mix of various species which could be: Red Oak, White Birch, Black Cherry, Sugar Maple, Aspen/Poplar (non-hybrid)

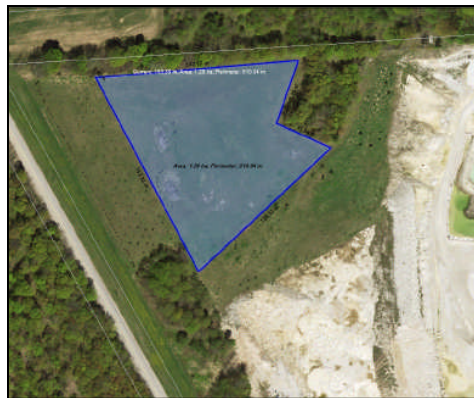
#### Sub-Compartment 7D

- Area = 1.28 ha or 3.16ac
- Full or 100% planting stocking density required
- Average tree planting density at 2.5m between rows and 1.7m spacing between trees
- Density target =  $1.28 \times (10000/4.25) = 3011$
- Planting requirement of 3000 trees, with a minimum height of 25cm at time of planting, composition being:
  - o Conifers = 2500
    - White Pine = 1800
    - White Cedar = 200
    - White Spruce = 500
  - o Hardwood = 500
    - A mix of various species which could be: Red Oak, White Birch, Black Cherry, Sugar Maple, Aspen/Poplar (non-hybrid)
