DUNTROON EXPANSION QUARRY

ADAPTIVE MANAGEMENT PLAN SUMMARY REPORT 2019

WALKER AGGREGATES INC.

PROJECT NO.: 111-53312-02
DATE: APRIL 30, 2020

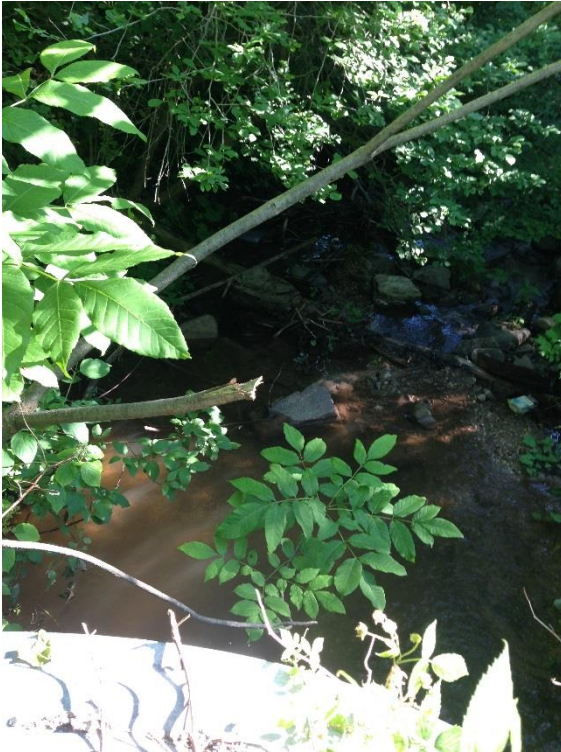
Photo 1 - Batteaux Creek sub-watershed control station

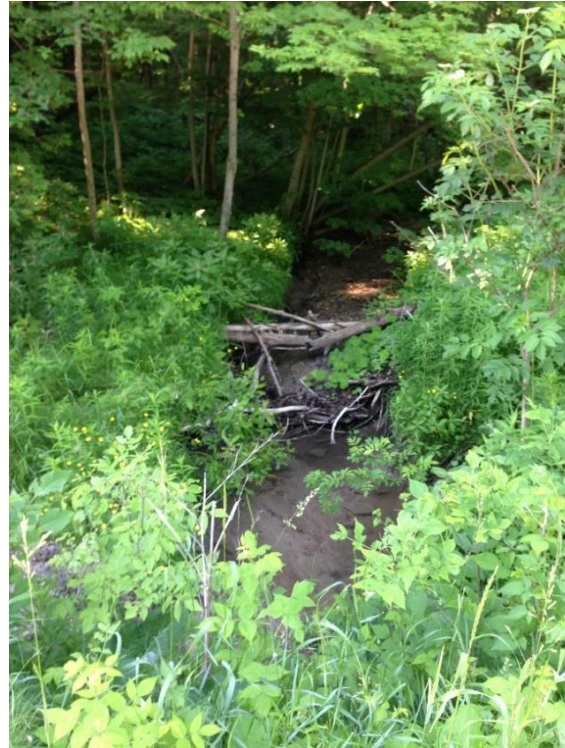
- Pretty River Sub-watershed Station (“PR Control”) – surface water control station located at the north side of the road culvert on 30/31 Sideroad, Town of the Blue Mountains, approximately 390 m west of the boundary line between Clearview Township and Town of Blue Mountains.

Photo 2 – Pretty River sub-watershed control station
