DUNTROON EXTENSION QUARRY

ADAPTIVE MANAGEMENT PLAN SUMMARY REPORT 2020

WALKER AGGREGATES INC.

PROJECT NO.: 111-53312-03
DATE: APRIL 30, 2021

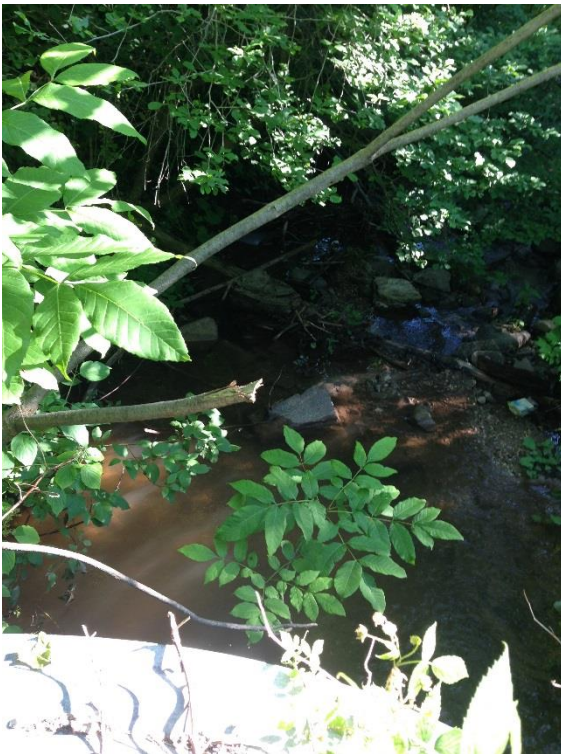
Photo 1 - Batteaux Creek sub-watershed control station

- Batteaux Creek Sub-watershed Station (“BC Control”) – surface water control station located at the north side of the road culvert on 21/22 Sideroad, Clearview Township, approximately 1350 m east of Concession 10.
- Pretty River Sub-watershed Station (“PR Control”) – surface water control station located at the north side of the road culvert on 30/31 Sideroad, Town of the Blue Mountains, approximately 390 m west of the boundary line between Clearview Township and Town of Blue Mountains.
